## Development of a non-destructive tool for inspecting the integrity of HDPE lined pipes

### Abstract

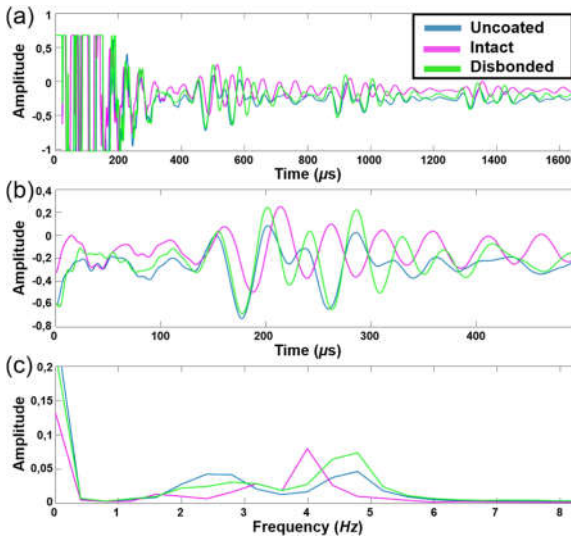
Next, using Matlab®, the A-Scan signals from the three regions were plotted together, as shown in Fig. 5.a, allowing for a comparison of the signal behavior differences. From the complete signal, the interval from 400  $\mu\text{s}$  to 700  $\mu\text{s}$ , corresponding to the first response echo, was selected, as shown in Fig. 5.b. In this comparison, besides the variation in signal behavior, it is possible to observe a time lag in the intact liner signal compared to the others, as well as a more subtle lag between the disbonded and uncoated signals. Figure 5.c shows the FFT of the A-Scan signal in the same time interval as Fig. 5.b. In this case, the difference in signal behavior in the analyzed regions becomes more evident due to the difference in amplitude.

Figure 5. (a) Comparison between the ultrasonic A-Scan signals in the intact, disbonded, and uncoated regions. (b) A-Scan signal of the three regions considering the first back echo in the interval from 400  $\mu$ s to 700  $\mu$ s. (c) FFT of the A-Scan signal of the three regions in the interval from 400  $\mu$ s to 700  $\mu$ s.

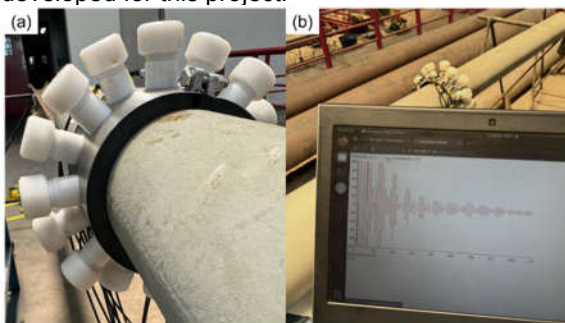
Thus, the successful ability to detect the integrity state of the HDPE internal polymeric lining in a carbon steel pipe was confirmed. Both the A-Scan and FFT signals demonstrated a clear distinction between the states, indicating a promising effectiveness in the inspection of this material. From this stage, testing of the inspection tool began on the remaining part of the pipe from which the half-pipe was removed. Figure 6.a shows the tool adjusted to the pipe body to be inspected, while Figure 6.b depicts the inspection setup with the tool in the background and the acquisition of A-Scan signals from the electronics and software developed for this project.

Figure 6. (a) Assembly of the inspection tool and (b) collection of A-Scan signals using the developed electronics.

Multichannel electronics was also developed to manage the tool and acquire the signals. These electronics allows the connection of up to 32 transducers simultaneously, the adjustment of inspection settings such as gain and window size with the acquired echo interval, and the saving of signals. All these mentioned points are performed remotely through the electronics' own Wi-Fi network, without the need for external internet access.
